Risk Management Series

for Improving Critical Facility Safety from Flooding and High Winds

FEMA 543 / January 2007

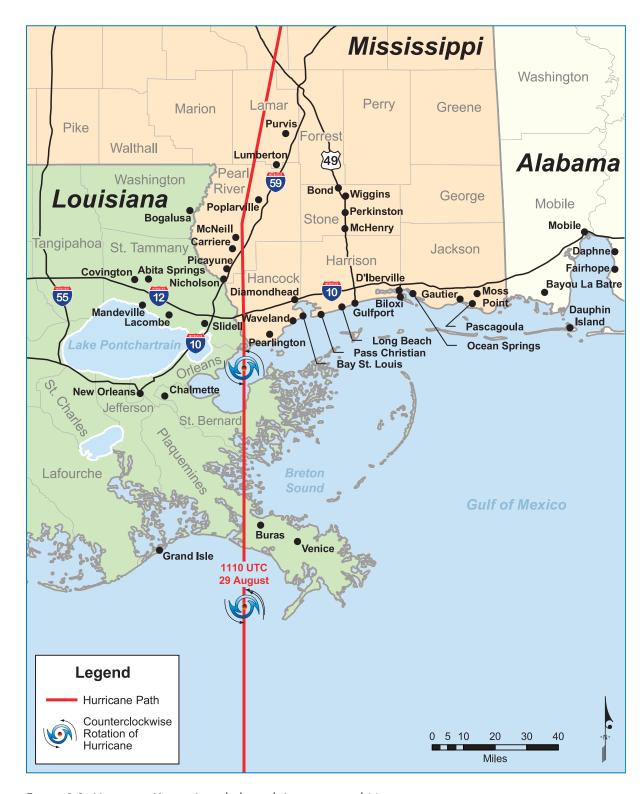
Figure 1-1: Hurricane Katrina's path through Louisiana and Mississippi (BASED ON HURRICANE STORM TRACK DATA FROM THE NATIONAL HURRICANE CENTER)

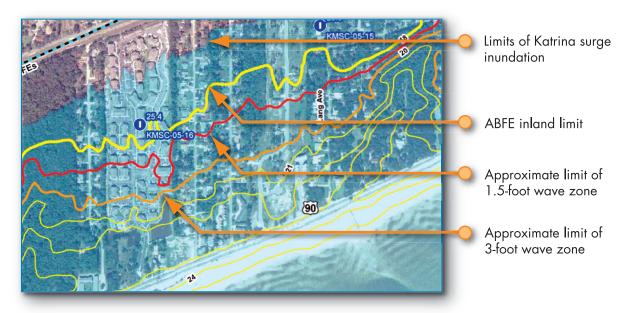
Figure 2-5: Example of a flood recovery map showing ABFEs and other flood hazard information.

FEMA works closely with communities to develop new flood hazard data or revise existing data during the standard flood study process. Updating flood hazard data includes the analysis of historical data. If a major flood event significantly alters the physical environment or if it is determined to be statistically significant, FEMA may decide to release Advisory BFEs (ABFEs) and Flood Recovery Maps (see Figure 2-5).

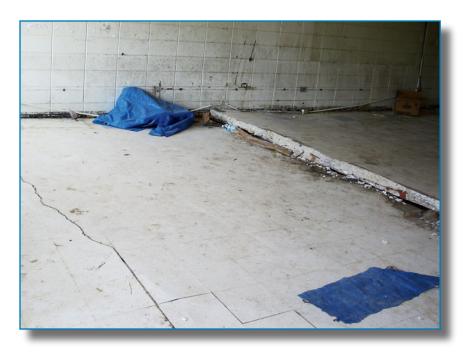
Figure 2-15: Concrete floor ruptured by hydrostatic pressure (buoyancy). Hurricane Katrina (2005)

Buoyancy and uplift: If below-grade areas are essentially watertight, buoyancy or uplift forces can float a building out of the ground or rupture concrete floors (see Figure 2-15). Buildings that are not adequately anchored can be floated or pushed off foundations. Although rare for large and heavy critical facility buildings, this is a concern for outbuildings and portable (temporary) units.

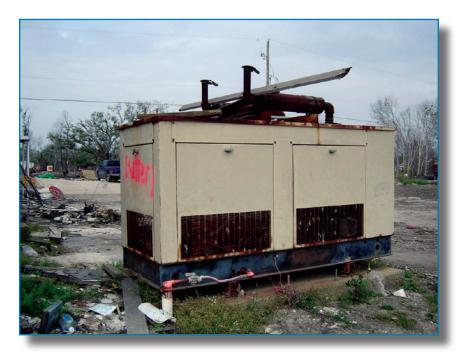
Figure 2-20: Although it was anchored and not displaced by floodwaters, this generator was out of service after being submerged.

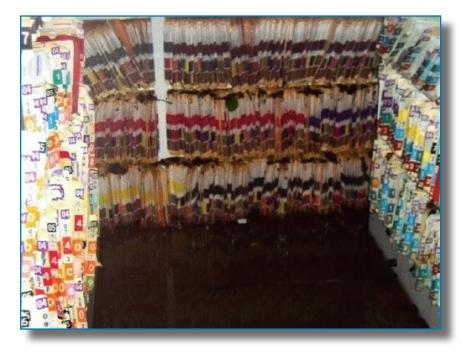
Figure 2-21: Medical records saturated by floodwaters

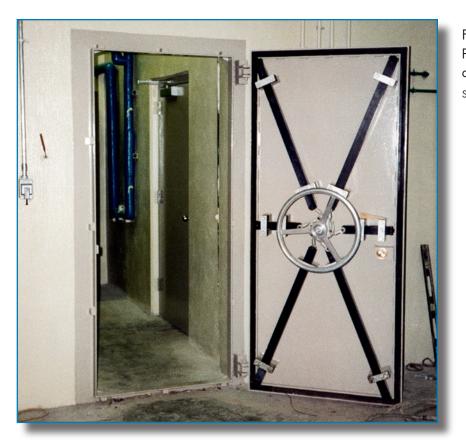
Figure 2-29:
Permanent watertight doors for deep water

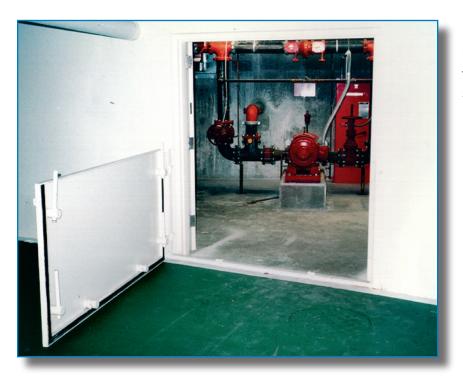
Figure 2-31: Equipment room with watertight door

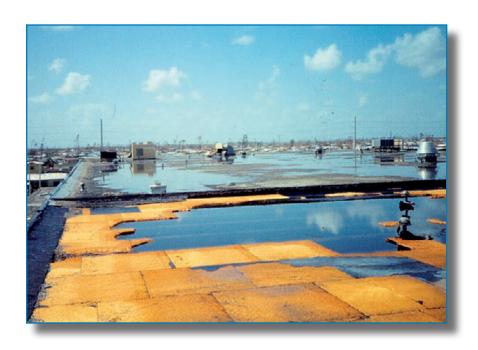
Figure 3-13: The outer window panes were broken by aggregate from a built-up roof. Hurricane Hugo (South Carolina, 1989)

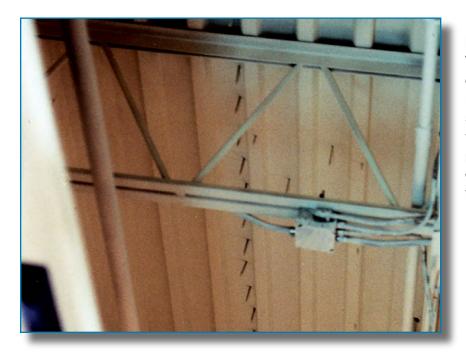
Figure 3-60: View of the underside of a steel deck showing the mechanically attached single-ply membrane fastener rows running parallel to, instead of across, the top flange of the deck.

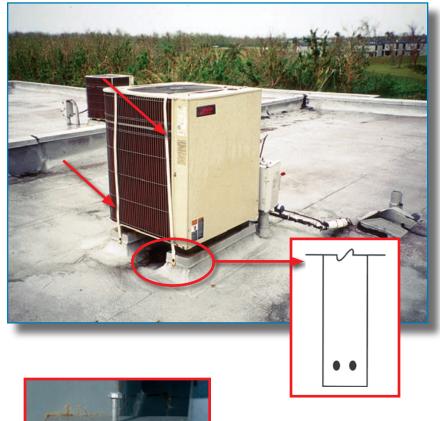
Figure 3-75:
Failure of vibration
isolators that provided
lateral resistance but no
uplift resistance caused
equipment damage.
A damaged vibration
isolator is shown in the
inset. Hurricane Katrina
(Mississippi, 2005)

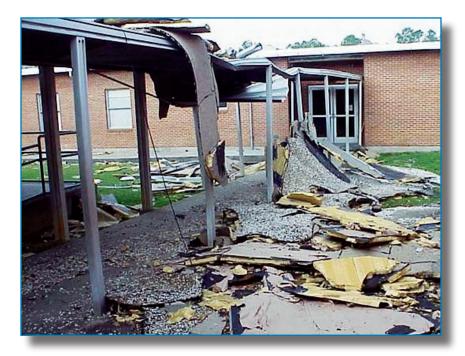
Figure 3-83: Open walkways do not provide protection from wind-borne debris. Hurricane Katrina (Mississippi, 2005)

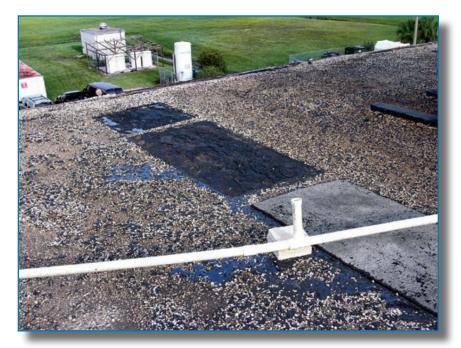
Figure 3-92: To avoid walkway pad blow off, as occurred on this hospital roof, walkway pads are not recommended. Hurricane Charley (Florida, 2004)

Walkway pads: Roof walkway pads are frequently blown off during hurricanes (Figure 3-92). Pad blow-off does not usually damage the roof membrane. However, wind-borne pad debris can damage other building components and injure people. Walkway pads are therefore not recommended in hurricane-prone regions.

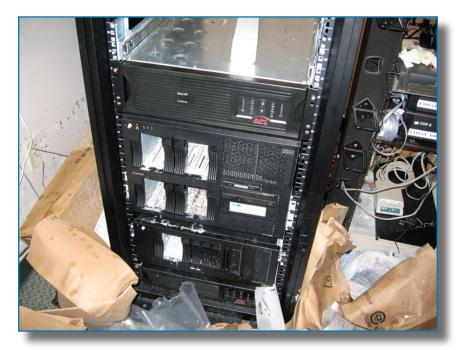
Figure 4-14:
Damaged computer
network equipment at
Hancock Medical Center

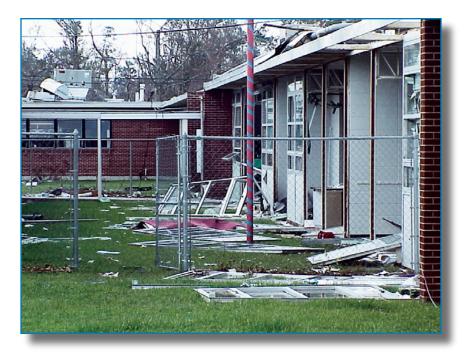
Figure 4-18:
Pineville Elementary
School shelter had to
be evacuated when the
floodwaters started to rise.

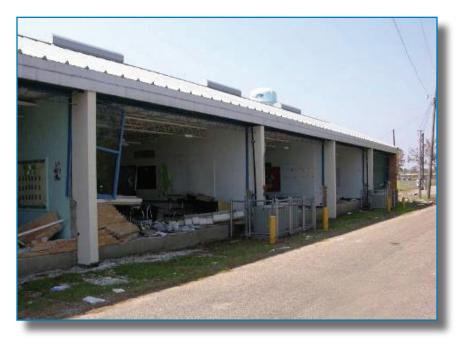
Figure 4-19: Exterior walls at Northbay Elementary School

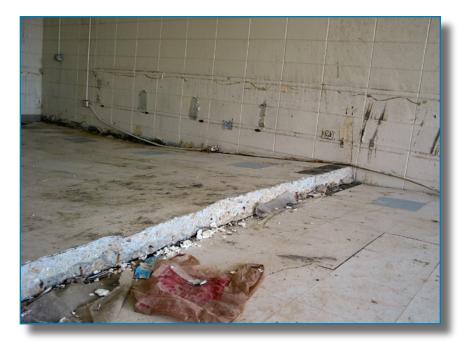
Figure 4-23: Cracked concrete floor slab at Charles B. Murphy Elementary School
